**AERONAUTICAL ACCIDENT INVESTIGATION  
AND PREVENTION CENTER**

**FINAL REPORT  
A-00X/CENIPA/2008**

**ACFT REGISTRATION: PR-GTD and N600XL**

**MODELS: B-737 8EH and EMB-135 BJ LEGACY**

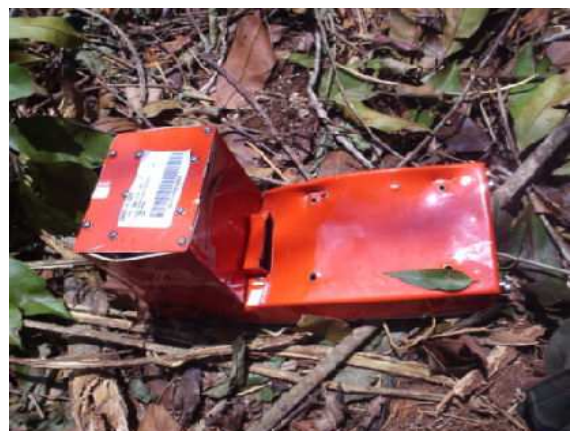
The direct impact of the SSVR unit against a tree trunk or branch was sufficient for the protected cylinder containing the data (Figure 19) to detach from the rest of the set (Figure 20).

**Figure 20:** Base of the SSCVR unit, PR-GTD
